Technical Data Sheet

Bridge Identification:	1111010000000B01
Facility Carried:	US 12
Feature Intersected:	St. Joseph River
Location:	Bertrand Township
County:	Berrien
Region:	Southwest
Year Built:	1954
Year Reconstructed:	1998
Bridge Type:	Two-Girder System
No. of Spans:	5
Deck Area:	15,120 S.F.
Paint System:	Type 1
Paint Area:	84,500 S.F.

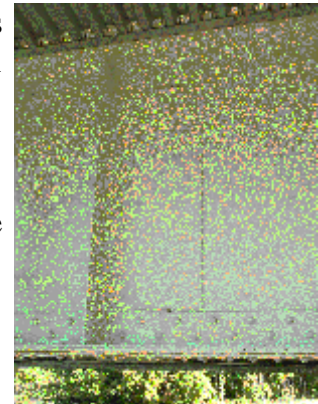
Welded Web Splice (4)

! **Welded web splices.** The welded web splices (Photo 4) should be carefully examined around their whole perimeter.

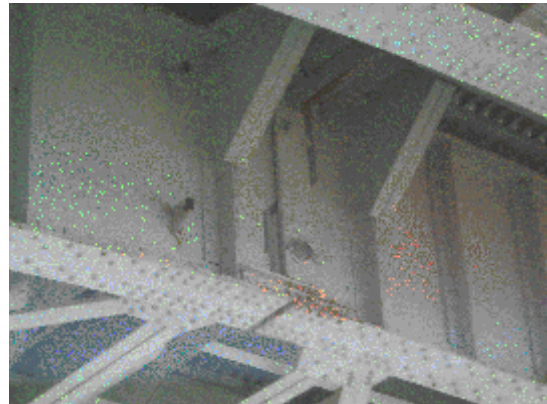
Pin and Hanger (5)

! **Pin and hanger assemblies.** The pins and hanger plates should be carefully inspected. There are plug welds connecting the channel that aligns the girders at the bottom of the connection. Plug welds are often an initiation point for cracking and should be inspected closely.
